Separate Battalions Barracks Complex

Volume IV of IV – Asbestos and Hazardous Waste Material Reports

Building No. 4661 Ft. Bragg, North Carolina

This report documents the supplemental asbestos inspection and survey of Building No.4661 at Fort Bragg, North Carolina conducted on 25 September 2002 by Savannah District US Army Corps of Engineers employees Tim Jones and Jack Ford. The survey was conducted in general accordance with the regulatory guidelines in the Asbestos Hazard Emergency Response Act (AHERA) (40 CFR Part 763 Subpart E Sections 763.80-763.88) and “Guidance for Controlling Asbestos-Containing Materials in Buildings” (Purple Book) (EPA publication number 560/5-85-024). Although not required by the AHERA guidelines, roof and other exterior miscellaneous materials were also inspected and sampled.

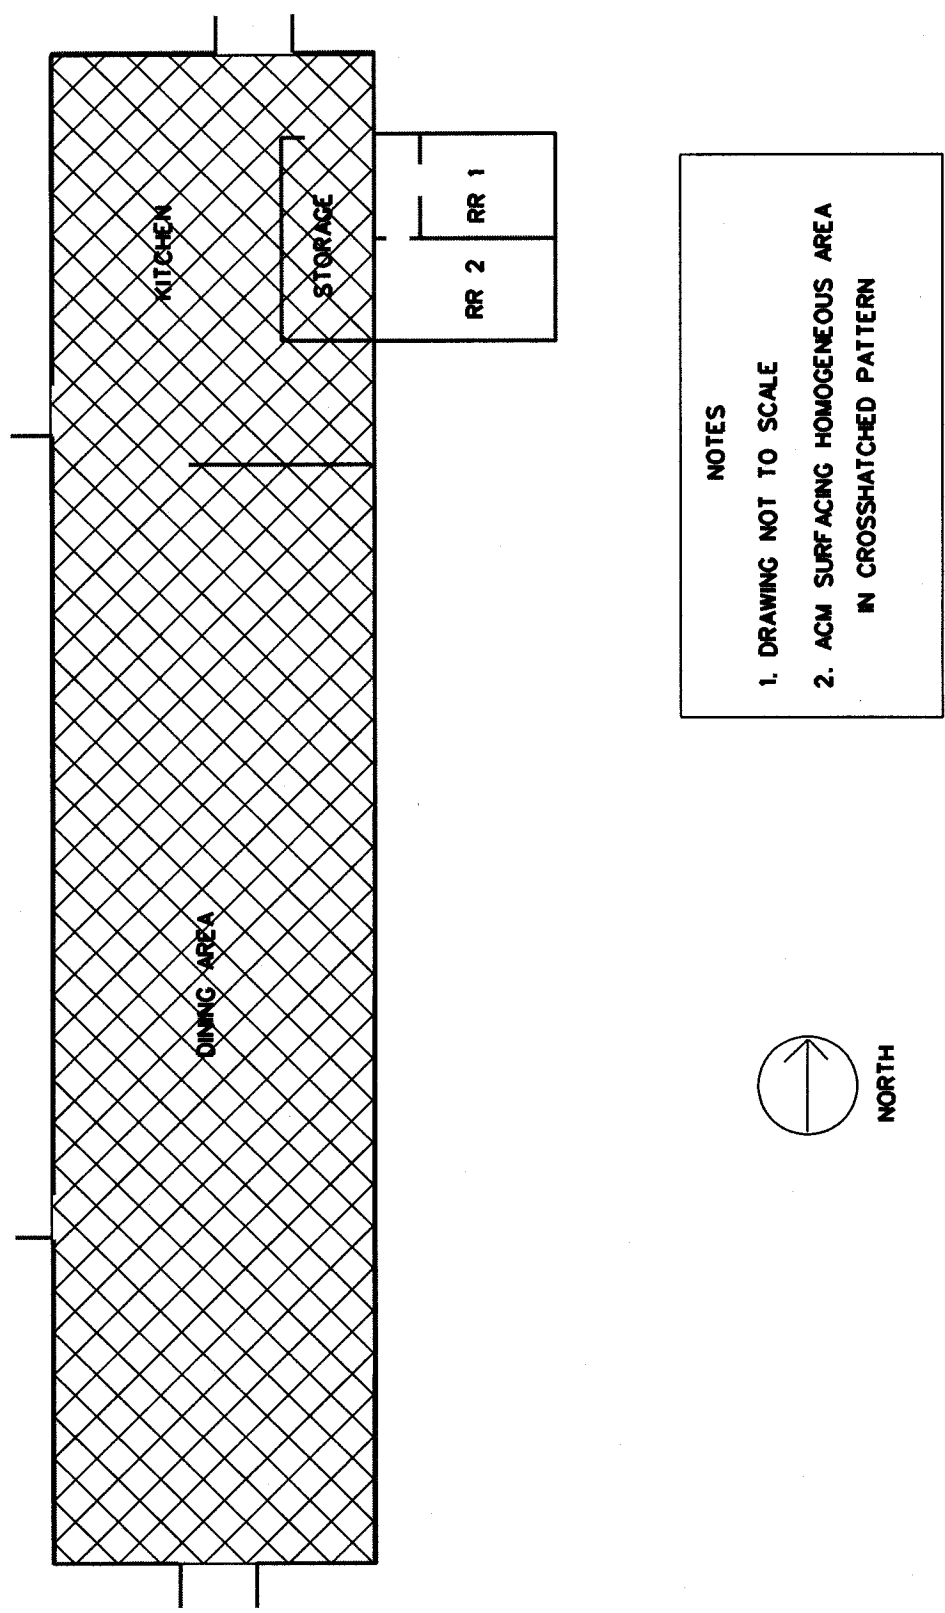
- a. *Drywall Joint Compound:* Gypsum drywall joint compound applied to old brown painted gypsum board wall and peaked ceiling covering above the newer flat ceiling in the dining and kitchen areas contains positive amounts of asbestos. This older drywall appears to have been removed from the location of the newer flat ceiling down to the floor and was only located in the "attic" space – (Refer to Tables 1, 2 and 3 for specific information and Figure 3 for homogeneous area locations).

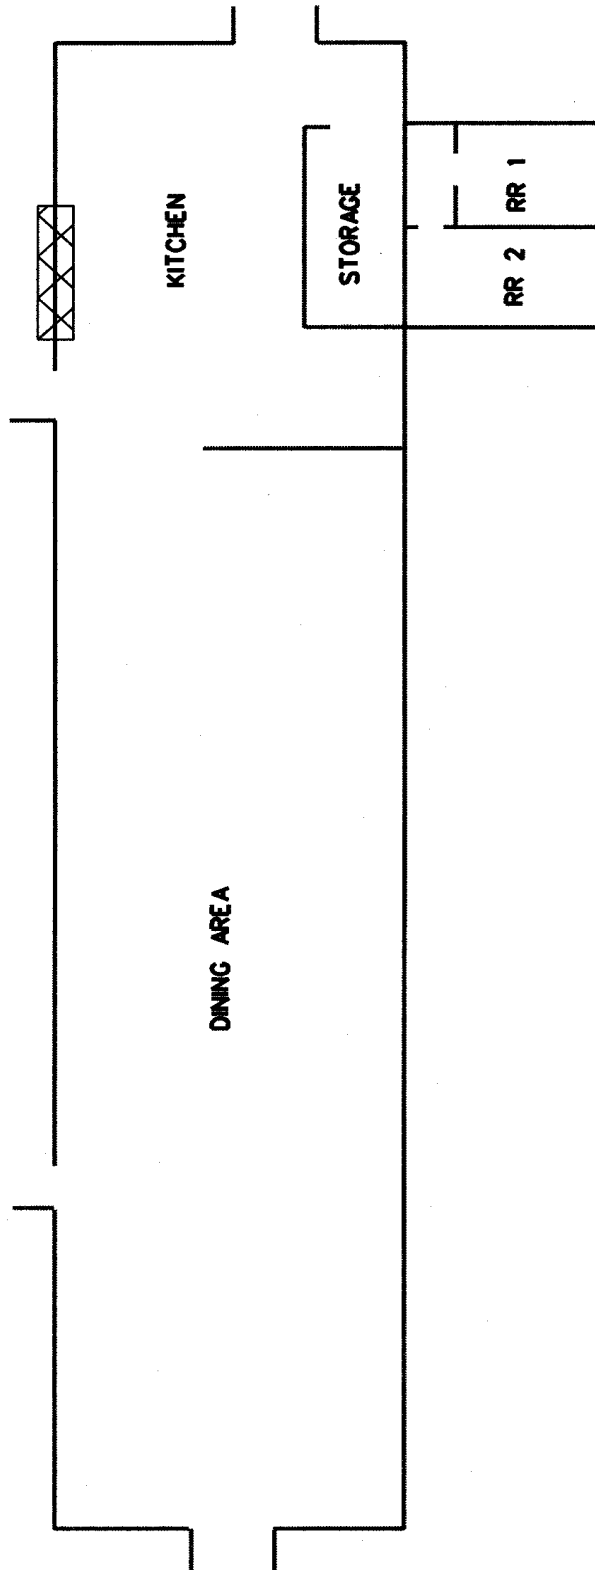
- c. *Cement Wall Board:* Asbestos containing cement wallboard (similar to Transite [™]) is applied to the wall at the location of the range hood from the floor to the ceiling. This material is approximately 1/4 " thick and is in approximately 4' X 8' sheets and appears to be screwed to the wall framing - (Refer to Tables 1, 2 and 3 for specific information, Figure 1 for sample location and Figure 4 for homogeneous area locations).

1. DRAWING NOT TO SCALE
2. ACM CEMENT BOARD HOMOGENEOUS AREA
IN CROSSHATCHED PATTERN

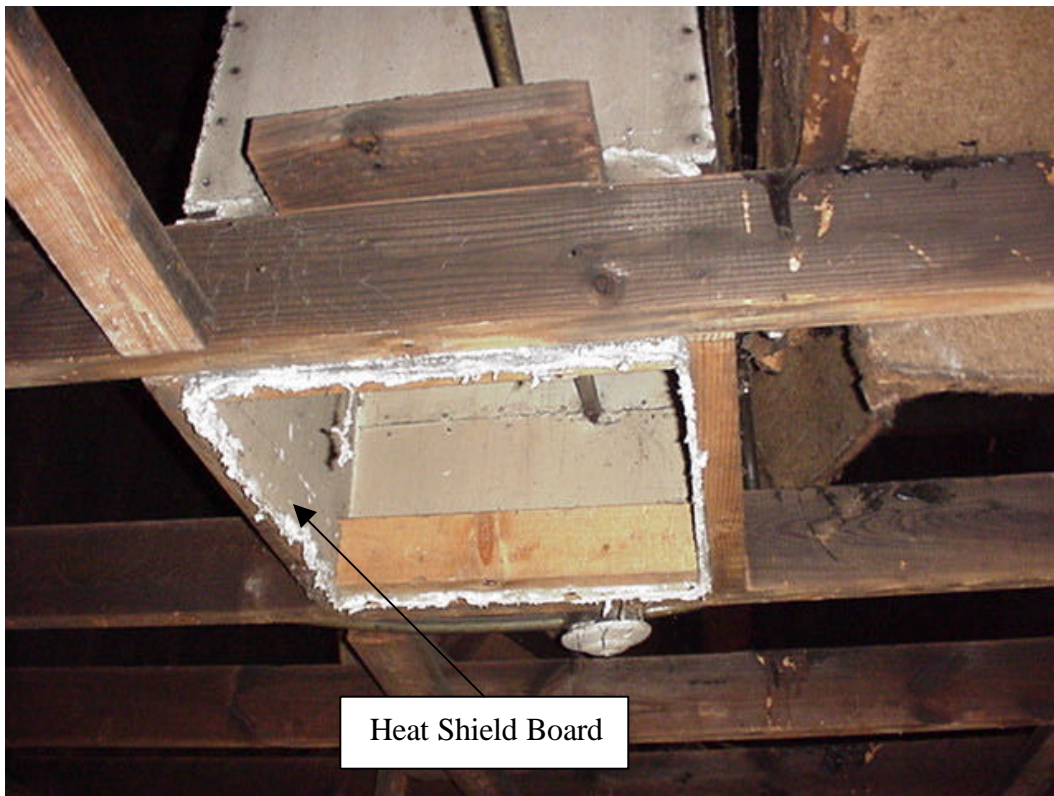
- d. *Heat Shield Material:* Asbestos containing heat shield board is applied to wooden framing for what was once a vent through the roof above the mezzanine level. Some of this material is also lying on top of the fiberboard ceiling approximately 6 feet south of the vent location. - (Refer to Tables 1-3 for specific information, Figure 1 for sample location, Figure 2 for homogeneous area locations and Figure 4 for visual material identification).

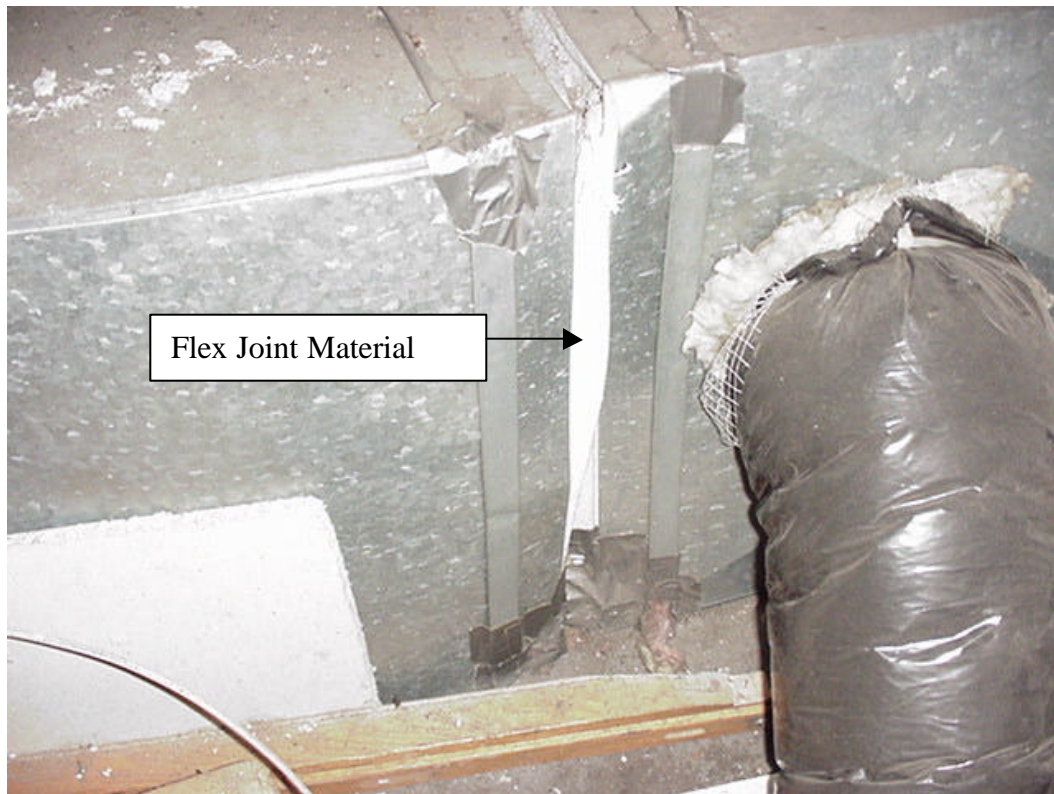
- e. *Duct Flex Joint:* Cloth flex joint (or vibration isolation) material in the ductwork at the mezzanine level contains asbestos - (Refer to Tables 1-3 for specific information, Figure 1 for sample location, Figure 2 for homogeneous area location and Figure 5 for visual material identification).
